Pitting Corrosion of Austenitic Stainless Steel Weld in Brewing Industry: Case Study

Sebastian Baloš, Dragan Rajnović, Danka Labus Zlatanović, Miroslav Dramićanin, Petar Janjatović, *Mirjana Trivković, *Milan Pećanac, Leposava Šidjanin

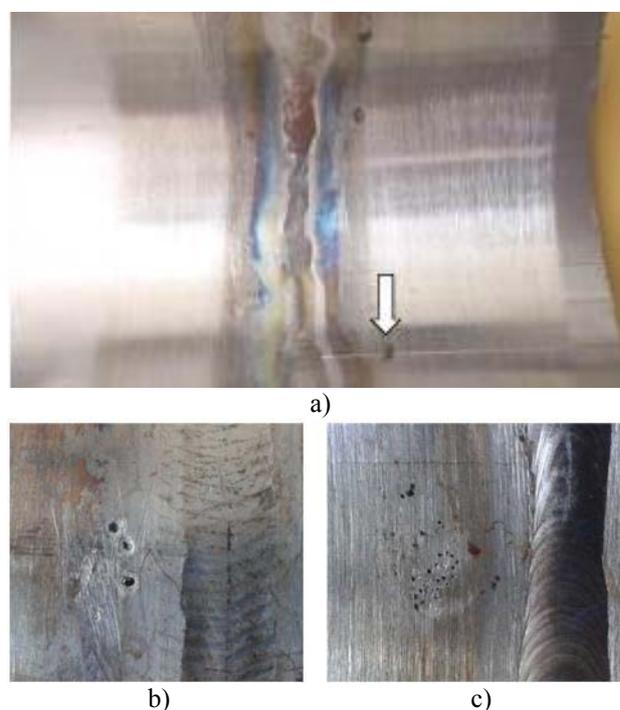
The examined specimens are shown in Fig.1. In Fig.1a, the weld zone is shown, with grinding marks that were the result of preparation done before welding. White arrow indicates corrosion spots within the ground area, at the distance of up to around 10 mm from the weld. In Fig.1b, c, a close up depiction is presented, where Fig.1b shows the external surface with fewer larger perforations compared to the internal surface shown in Fig.1c. Grinding marks can be also observed in Fig.1c. Furthermore, tinting area around the weld can be seen, closely corresponding to C-level of heat tint, that is, 32 ppm oxygen concentration, Fig.2. [8]. Heat tint is the surface that contains different inhomogeneities and damage to the oxide layer that may impair the passivity of stainless steel. This surface is electrochemically active and liable to corrosion. Although recommended oxygen concentration is under 1 ppm (level A in Fig.2) [9].

Fig.1 Specimens examined, the area shown is near 6 h in the tube (bottom part)

On the other hand, although the forming shielding gas was used, heat tinting could be observed. It is an indicator of the presence of over 1 ppm oxygen in the pipe and closer to 32 ppm during welding. That means, forming gas was not applied long enough to expel oxygen from the inside of the pipe. Heat tinting further degraded corrosion resistance of the pipe material. To avoid corrosion problems, heat tinted welds should have been post-treated with HF, HNO₃ or H₂SO₄ (passivation process) [12].

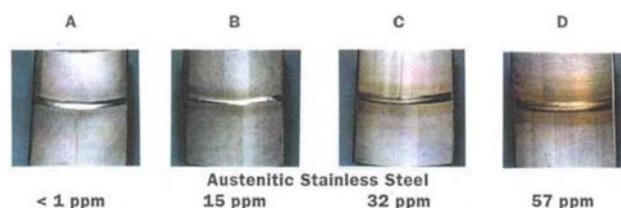
Fig.2 Heat tint levels [8].

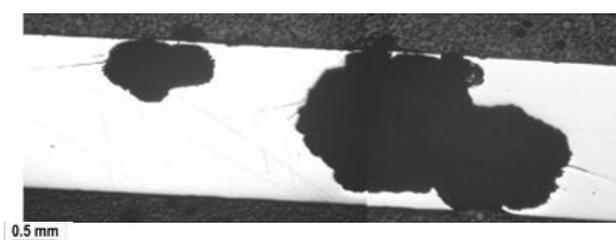
Cross section of the pipe in the corrosion zone is depicted in Fig.3, where the top is the inside of the pipe. Two pits are found, one partially, and one fully penetrating the wall, clearly indicating that the corrosion first occurred in the

inside of the pipe. As the pipe is used to transport beer, the most probable cause of corrosion is the cleaning in place by an alkaline cycle (0.5-2 % NaOH at 60-80°C), whereas the acidic cycle is performed with 1 – 2 % HNO₃ at ambient temperature. In Fig. 4, weld zone is presented, with large non-penetrating corrosion pits and the weld metal with typical morphology. Microstructures of base metal and melt line including weld metal are shown in Figs. 5 and 6. Base metal microstructure is austenitic (Fig.5), which is in accordance with the chemical composition shown in Table 1. Weld metal has a columnar morphology in the direction of heat transfer towards base metal. Finally, in the heat affected zone, there is austenitic grain coarsening.

Fig.3 Cross section of the pipe in the corrosion zone

Pre welding grinding, probably by wire brush tool mounted on the power drill, that was done before welding, was done supposedly to clean the inner part of the pipe was unnecessary. It created creases in material, which kept acidic cleaning agent. Although containing a relatively low 1 – 2 % HNO₃ in water, which is not sufficient to cause corrosion in 304L austenitic stainless steel, hence it is used for cleaning purpose. However, creases created by wire brush kept the acidic agent, water solvent evaporates and the concentration of HNO₃ is increased to the level that makes it corrosive [10]. Stainless steel surface should have been kept smooth, in as-received condition [11]

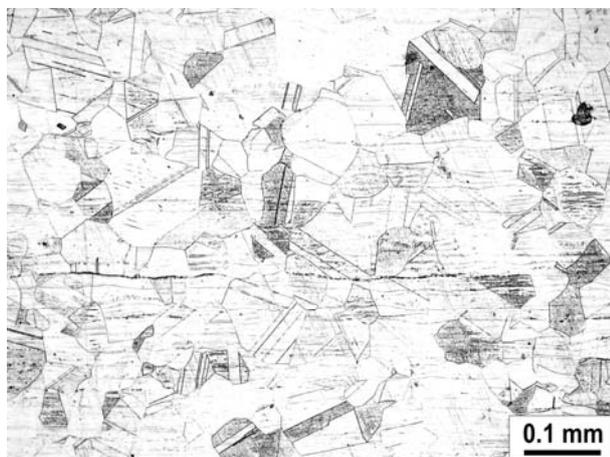
Fig 5 Base metal microstructure

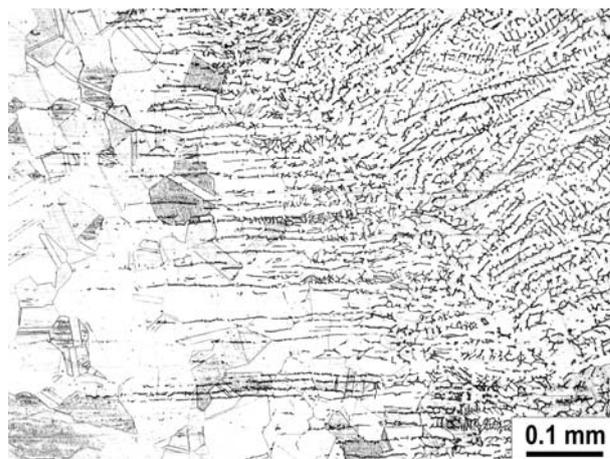
Vickers hardness test results in base metal, heat affected zone (HAZ) near melt line and weld metal is shown in table 2. The lowest hardness was obtained in the weld metal, followed by HAZ near melt line. Hardness values in the HAZ near melt line are lower compared to base metal due to austenitic grain coarsening effect reported in Fig. 6.

Fig.6 Right-weld metal, center-melt line, left heat affected zone
